Young's Inspection, LLC

June 11, 2024

RE: Structural Assessment – Vacant Buildings Located at 201 S. Harrison St. and
5, 7, 9, 13, 15-17 W. Broadway St., Shelbyville, IN

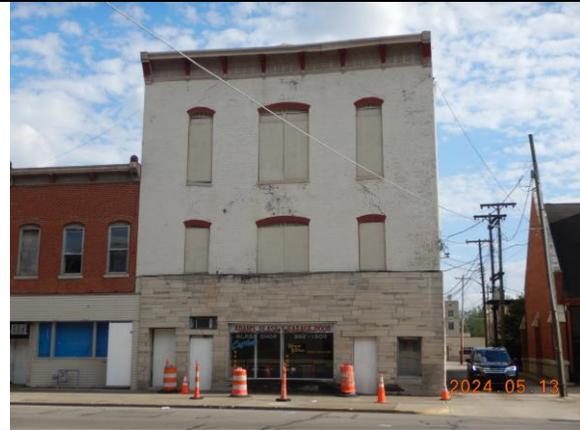
Exterior - There is significant damage to the west building load bearing brick masonry walls. Damage is due to differential foundation settlements and long-term water/moisture intrusion. The added limestone veneer at the front and right side of the building is bulging outward towards the north and is in danger of collapsing onto the sidewalk and street. The overhanging cornice feature at the top of the front wall has moved outward towards the north. All three buildings need significant major repairs to their exterior.

West building front elevation

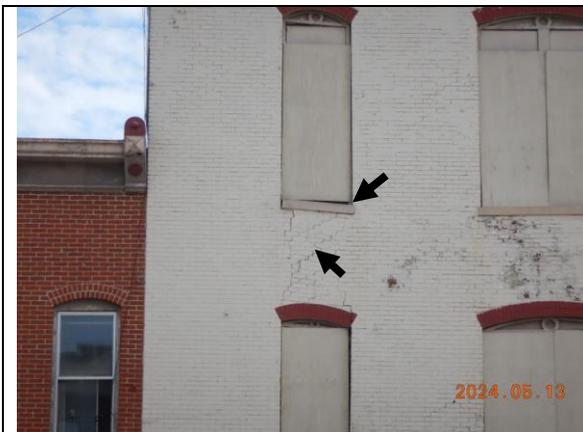
Structural damage & masonry cracking above and below windows/Window frames are not square

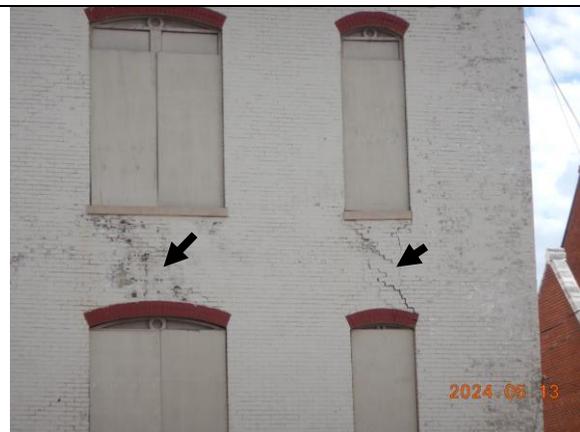
Structural damage & masonry cracking above and below windows/Window frames are not square

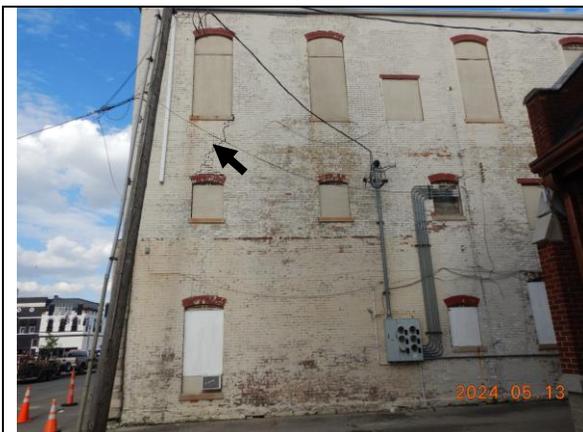
Structural damage & masonry cracking above and below windows/Window frames are not square

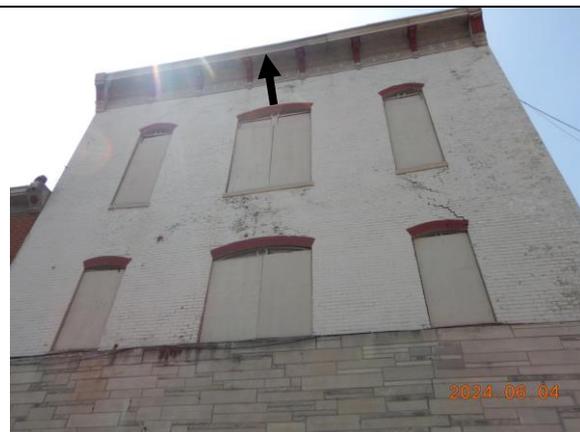
Cornice feature has moved outward towards the north

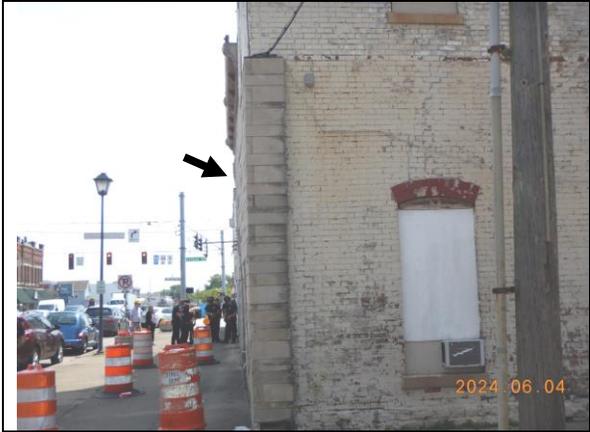
Limestone veneer is bulging outward

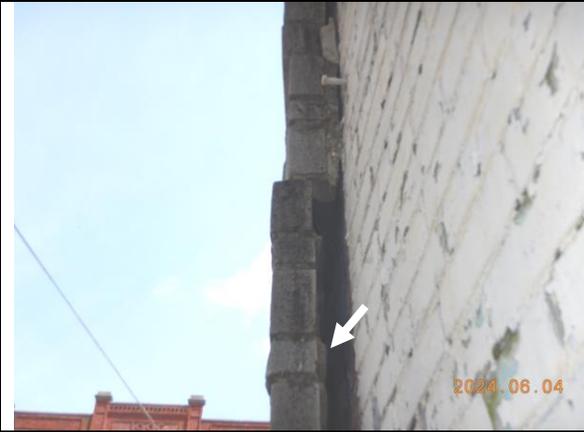
Limestone veneer is bulging outward

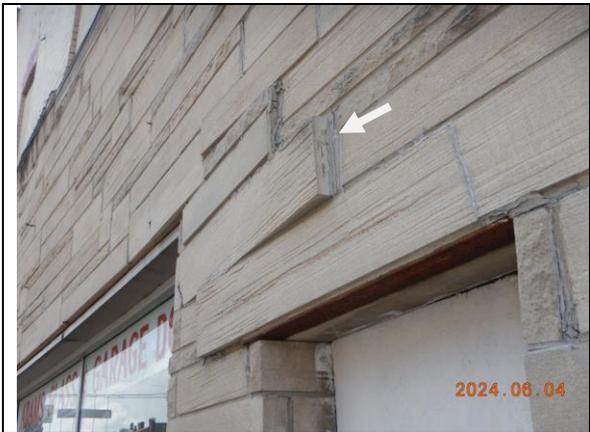
Limestone veneer has moved out of the plane of the wall

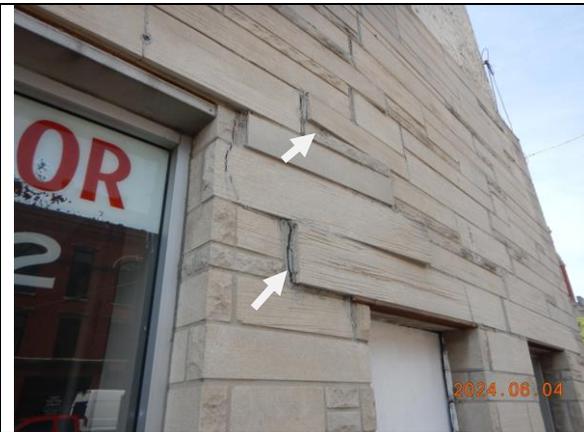
Limestone veneer has moved out of the plane of the wall

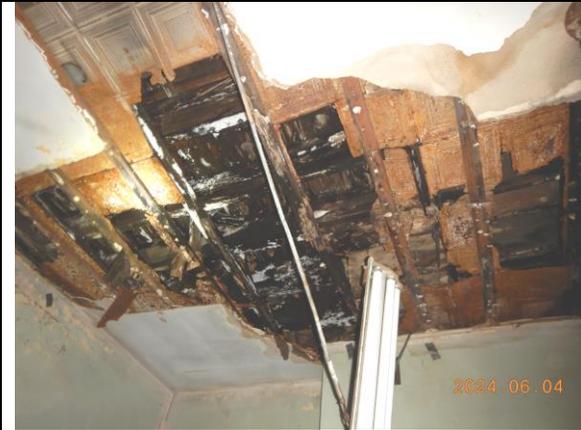
Interior – All three buildings have significant structural damage to the interior from roof leakage, water intrusion and apparent occupant abuse. Floors are rotted, sagging and not safe to walk on. The roof structure, ceilings and walls are significantly damaged and in a state of disrepair at all the buildings. The buildings have a lot of trash, debris and health hazards. A large amount of apparent mold-like biological growth and suspected asbestos containing material is present.

Structure damage at west building

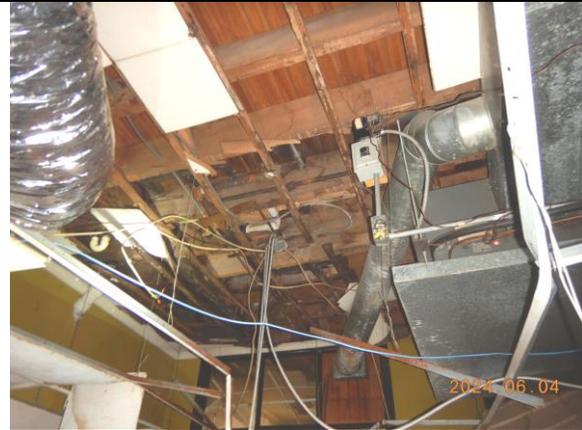
Structure damage at west building

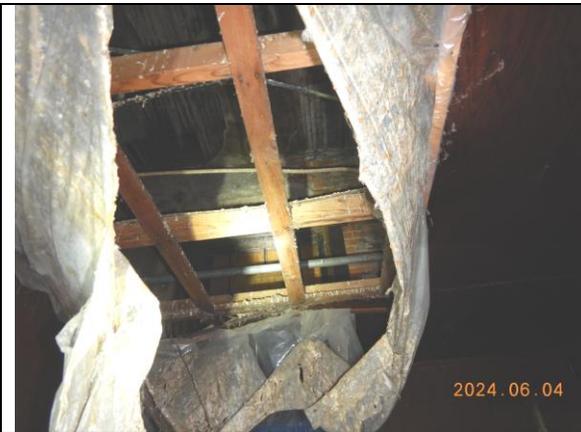
Structure damage at west building

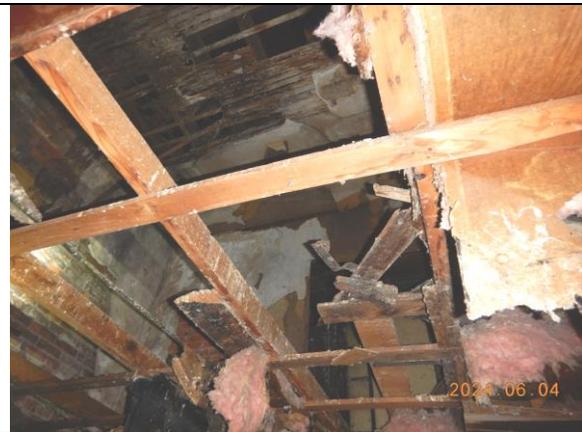
Structure damage at west building

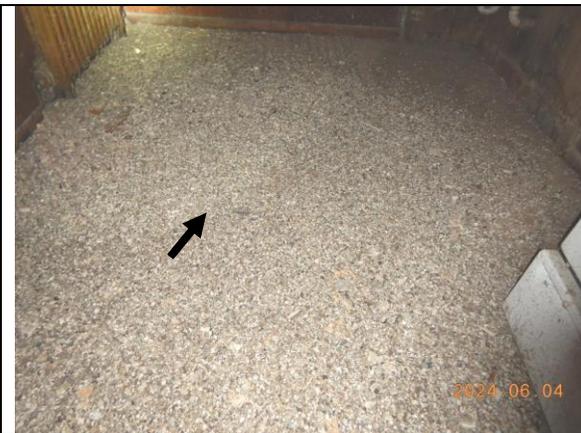
Very large pile of bird droppings on 3rd floor of west building

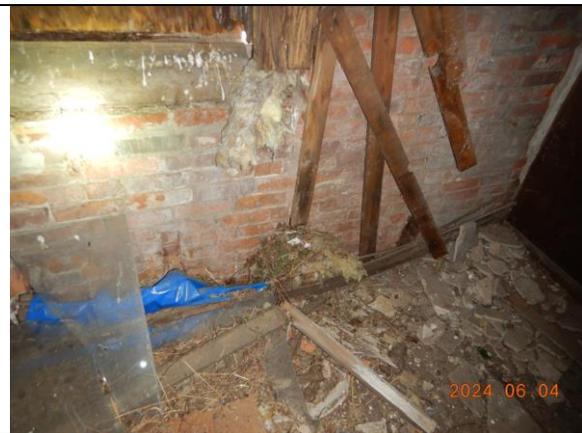
Structure damage at west building

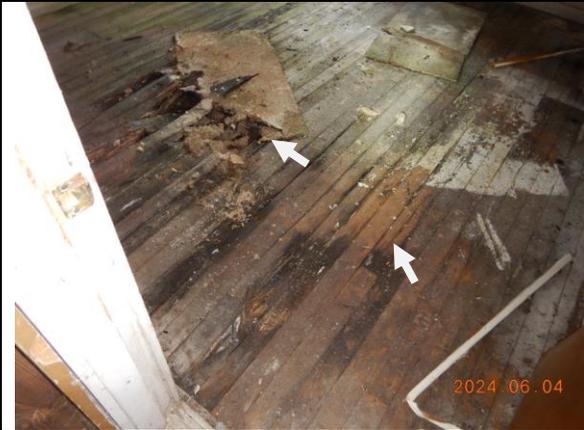
Floor damage at center building / Unsafe to walk on floorboards

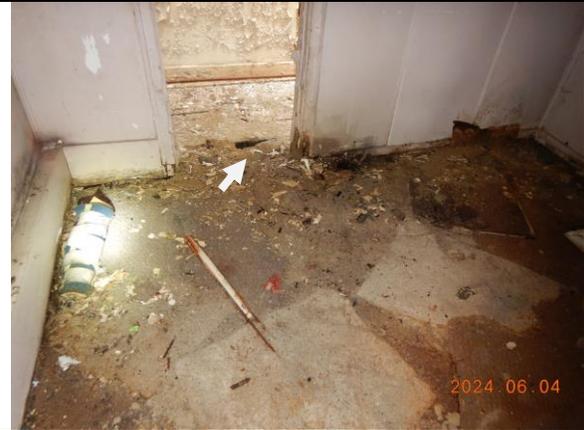
Floor damage at center building

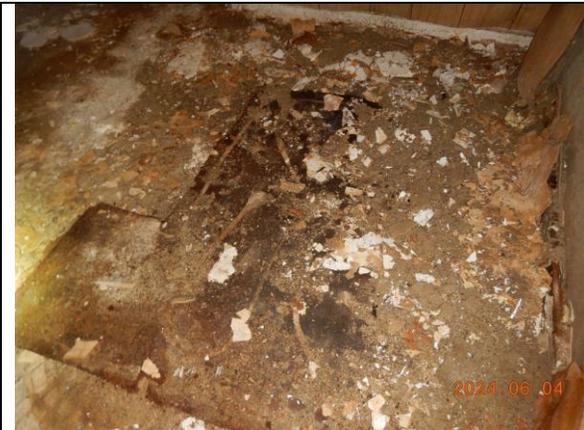
Floor damage at center building

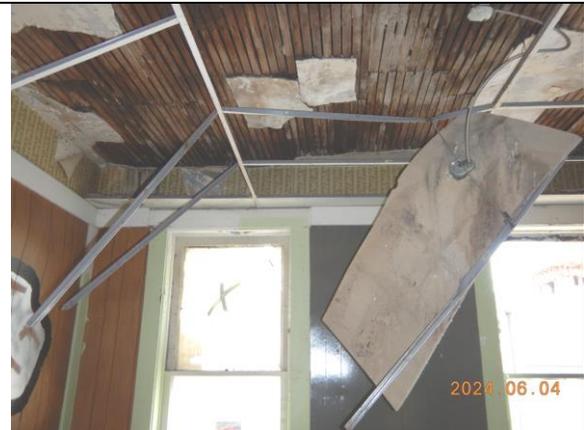
Structure damage at center building

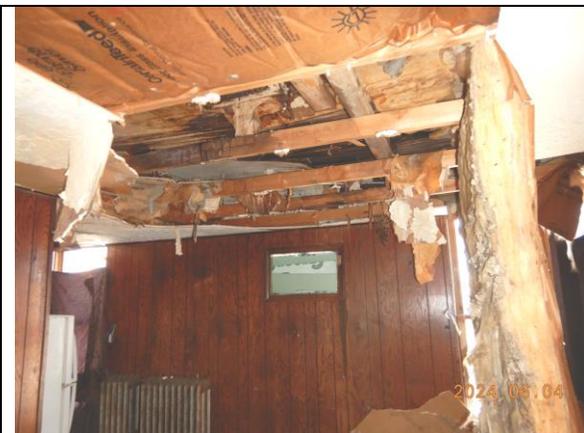
Structure damage at east building

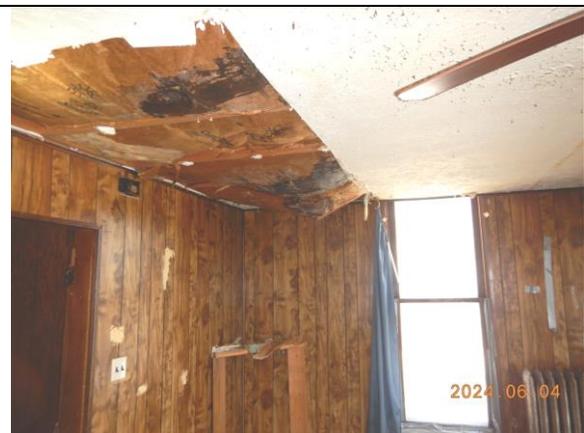
Structure damage at east building
