Young's Inspection, LLC

June 11, 2024

RE: Structural Assessment – Vacant Buildings Located at 201 S. Harrison St. and
5, 7, 9, 13, 15-17 W. Broadway St., Shelbyville, IN

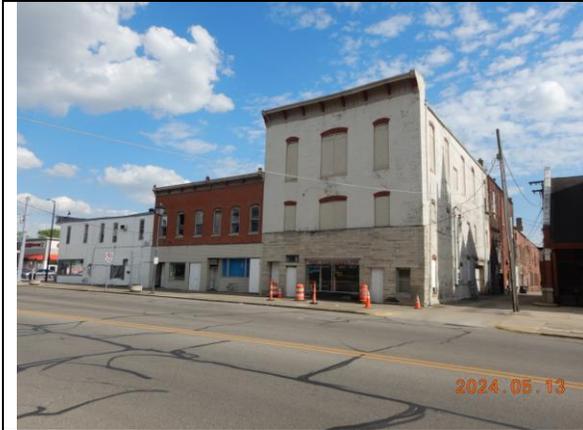
East, Center and West Buildings

Exterior - There is significant damage to the west building load bearing brick masonry walls. Damage is due to differential foundation settlements and long-term water/moisture intrusion. The added limestone veneer at the front and right side of the building is bulging outward towards the north and is in danger of collapsing onto the sidewalk and street. The overhanging cornice feature at the top of the front wall has moved outward towards the north. All three buildings need significant major repairs to their exterior.

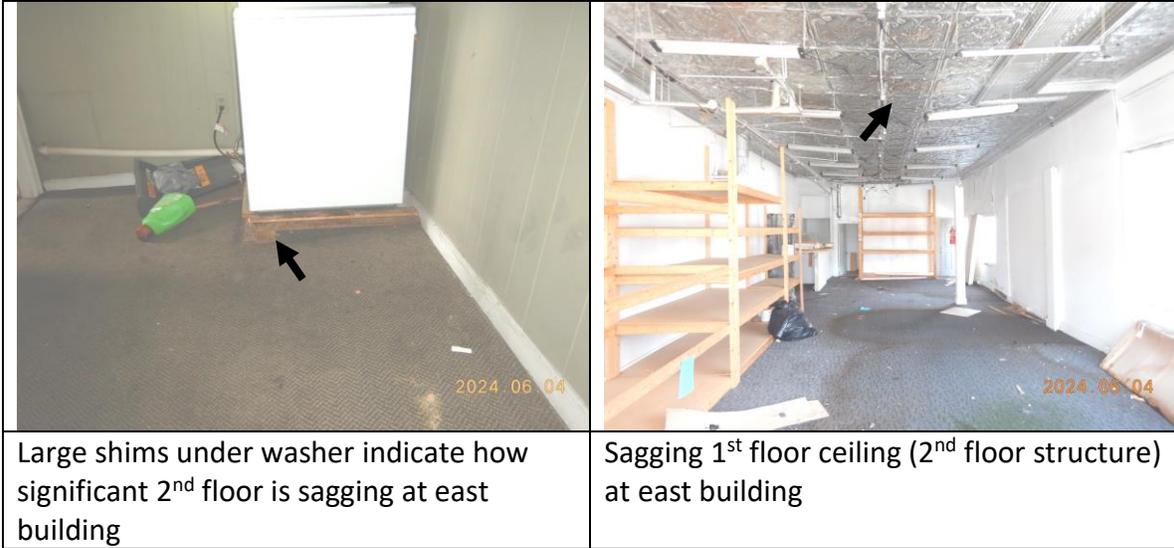
Structure damage at east building

In summary, I didn't find anything about the properties to be in a "serviceable" condition. My professional opinion is the properties are not safe for occupancy and have great potential for further damage and/or collapse. A great expense would be needed to restore and repair buildings to a safe and habitable condition. It may be better from an economic standpoint to consider removal of the buildings.
